Evaluation of Fish Injury and Mortality Associated
with scale models of the
Pentair Fairbanks Nijhuis Modified Bulb turbine
and the
Water2Energy Cross Flow turbine

Report number: 20140961/rap02
Status: Final report
Date: 1-9-2015

Author: F.T. Vriese
Project manager: F.T. Vriese
Supervisor (ATKB): J. Hop

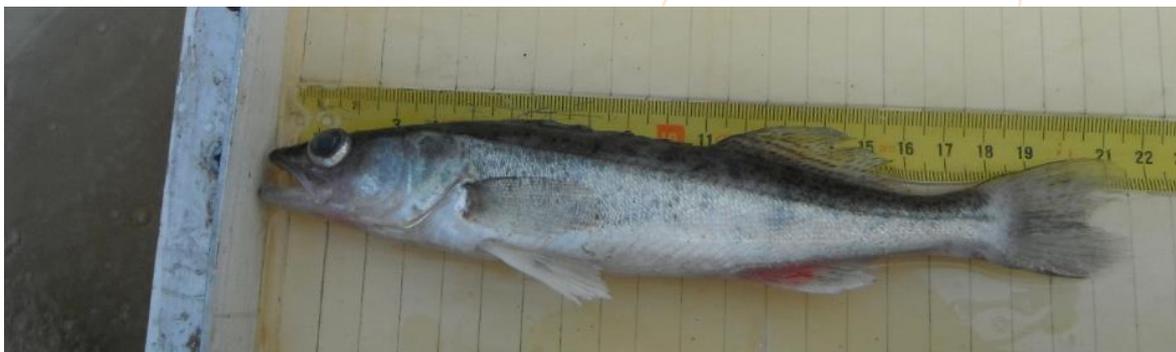
After performing test 1-1 it became obvious that there were several instant mortalities as a small number of fish was floating in the low water tank. In total 6 dead fish were counted with severe bruising/fracturing, damage to the eyes and haemorrhaging.

Figure 19. Dead pike perch, with severe bruising, damage to the eyes and haemorrhaging

In general all 6 fish show the same type of lethal damage, likely due to collision with turbine blades. Death was probably instant, due to severing the artery from the Bulbus arteriosus, causing heavy internal bleeding resulting in pale gills, rupturing of the swim bladder.

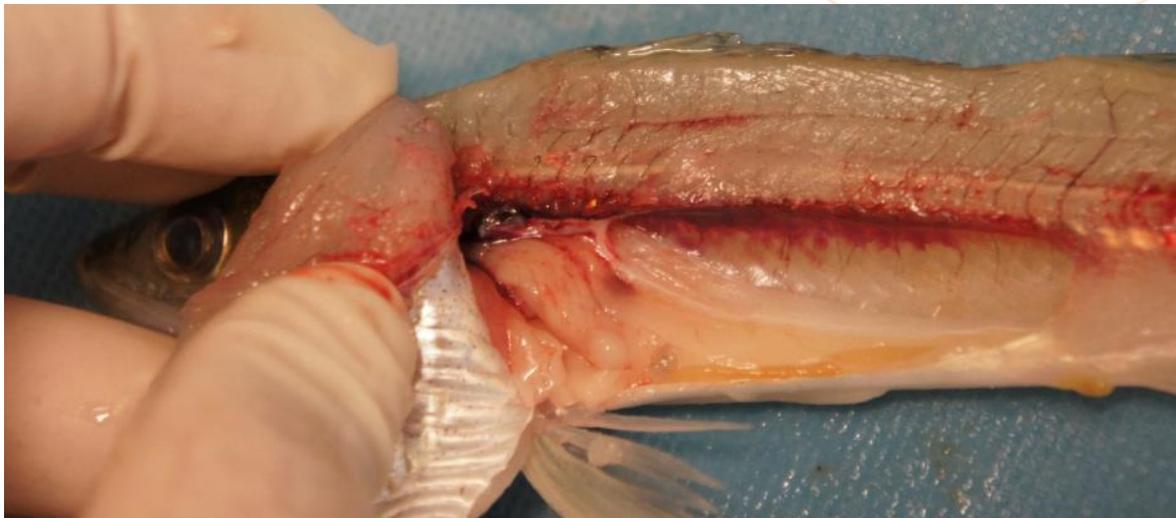
Figure 20. Pike perch with severe internal bleeding due to rupture of artery

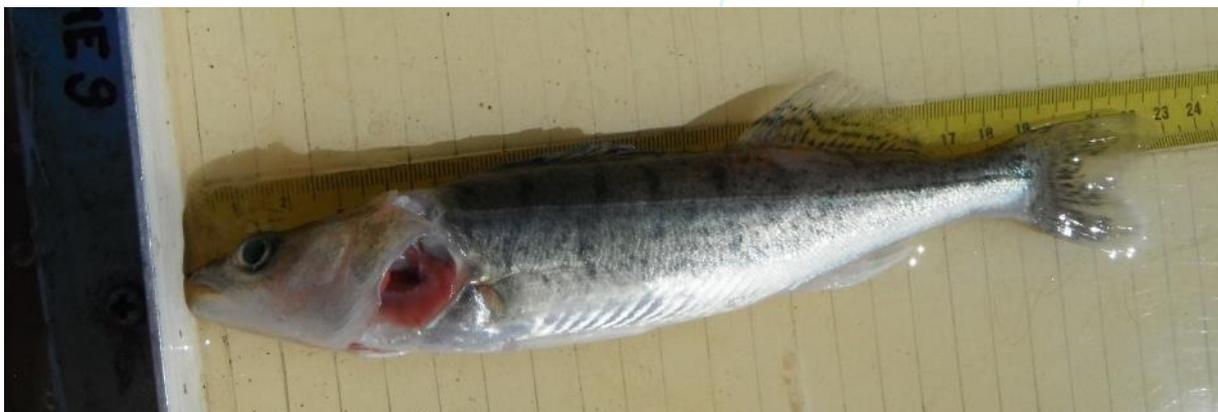
Test 1-1, with the cross flow turbine, led to 6 fatalities. One of these fish had a fractured spine just posterior of the head (figure 21). The other fatalities were also collision victims, suffering from severe bruising in the region of the head mainly, haemorrhaging (figure 22) and some damage to pectoral fins.

Three pike perch suffered some slight damage in the form of bruising near the head or in the dorsal area. Mortality after 48 hours was zero. Although no autopsy was performed, due to the nature of the damage and injuries, same causes of death are likely. Severe bodily trauma due to collision with moving parts of the turbine.

Figure 21. Pike perch with fractured spine just posterior of the head

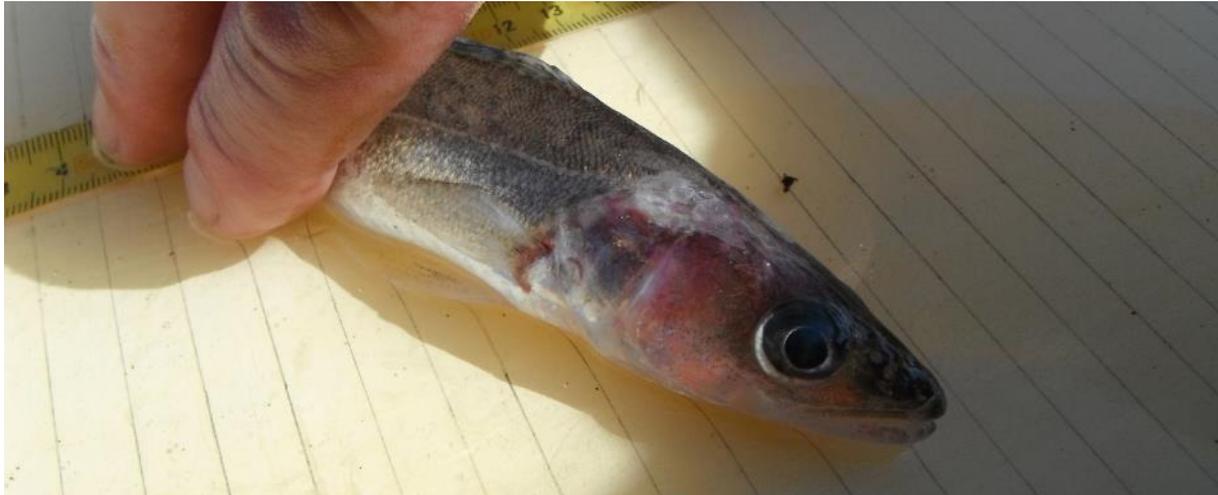
Figure 22. Severe bruising and haemorrhaging near head
