Evaluation of Fish Injury and Mortality Associated
with scale models of the
Pentair Fairbanks Nijhuis Modified Bulb turbine
and the
Water2Energy Cross Flow turbine

Report number: 20140961/rap02
Status: Final report
Date: 1-9-2015

Author: F.T. Vriese
Project manager: F.T. Vriese
Supervisor (ATKB): J. Hop

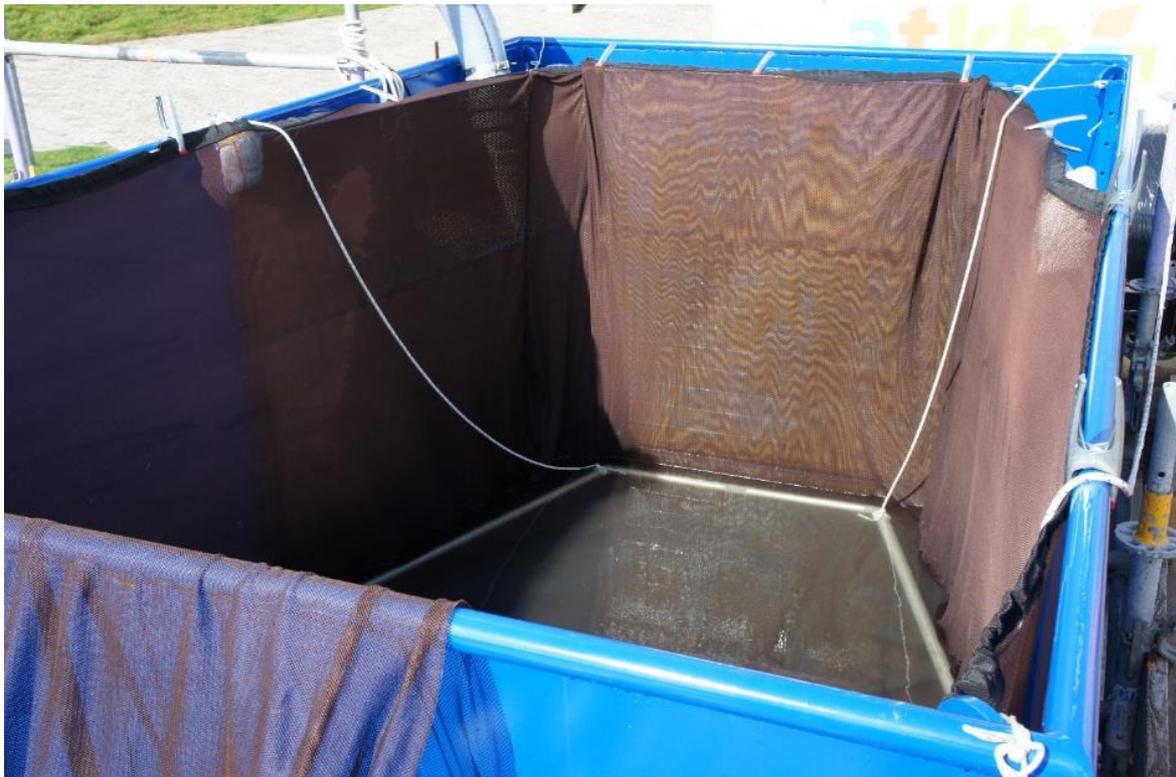
Figure 15. Low water tank with collection net for fish

A collection net was used in the low water tank to prevent fish from escaping to the river. A heavy frame prevented the net from moving to and fro and thus possibly damaging the fish. Fish could escape to the river through a small opening below the baffles, hence the collection net was necessary. The net was not necessary for removing the fish because it turned out to be just as easy to go into the

Insertion of fish in the test rig was very easy and fast. Water with fish could be dosed perfectly and the transport of the fish through the turbine into the low water tank only took seconds. As it turned out, the dimensions of the collection net was not in accordance with the actual size of the low water tank. This proved not to be a great set back as adaptations could be made on site. After the test and collection of the fish from the low water tank, fish were slightly anaesthetized and checked for damage. All damaged fish were photographed. After this procedure fish were stored in vertical keep nets attached to a line with floating buoys (see figure 24). When the experiment had ended, fish were released on site.

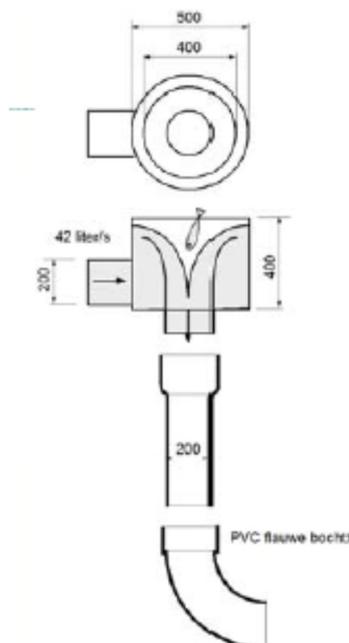
The specially designed fish intake structure turned out to work very well (figure 17 and 18). The structure had its own water supply (42 l/s) by smaller pumps in the high water tank and in the low water tank. The water enters the top end of the structure and then flows over the edge into the funnel. Water with fish can be added from above and the constant flow takes the fish away down through the insertion pipe (diameter 0,2 m) in a very gentle way. The horizontal part of insertion pipe was actually somewhat longer than depicted in figure 17 and reached well into the large pipe leading to the turbine, to prevent fish from swimming back to the high water tank. The flow velocity in the insertion pipe and the large pipe was approximately 1,5 m/s, fast enough to carry the fish to the turbine. The distance from the insertion point to the turbine however, was long enough to give fish time to orientate themselves in the flow. From high speed camera footage it could be concluded that most fish, passing through the turbine, performed controlled swimming. Only very few fish succeeded in swimming against the current and reaching the high water tank.

Figure 17. Intake structure for fish

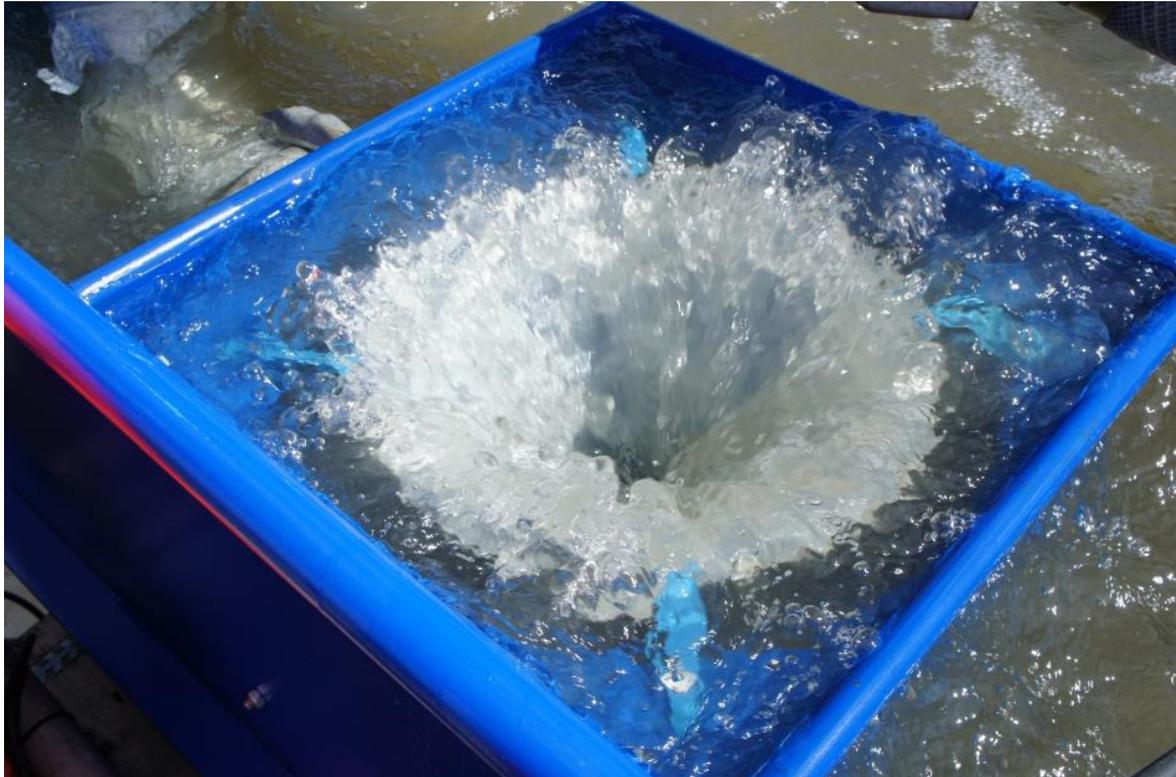
Figure 18. Intake structure supplied with water

As mentioned before the fish intake structure functioned very well. It was easy to inject the fish in a controlled manner (i.e. almost one by one) in a way that is certainly not damaging the fish. Care had to be taken to apply the correct amount of water passing through the intake structure. If the water supply was a low, air was entrained into the water leading to air bubbles passing the viewing chamber and obscuring visibility.

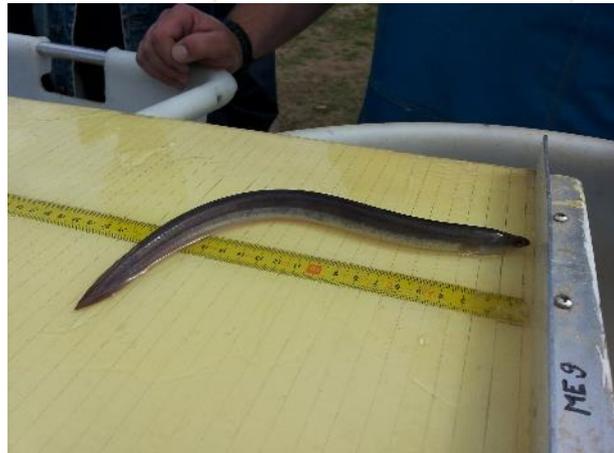
Test 3-1 did not result in any fatalities among the yellow eel. None of the eel suffered any damage. Mortality after 48 hours was zero.

Figure 23. A perfectly healthy eel after testing

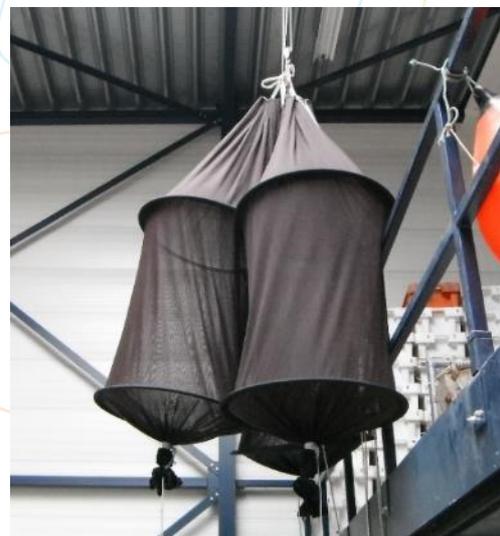
Figure 24. Vertical keep net for storage of fish
